ombudsman VICTORIAN

**Investigation into allegations concerning rail safety
in the Melbourne Underground Rail Loop**

October 2012

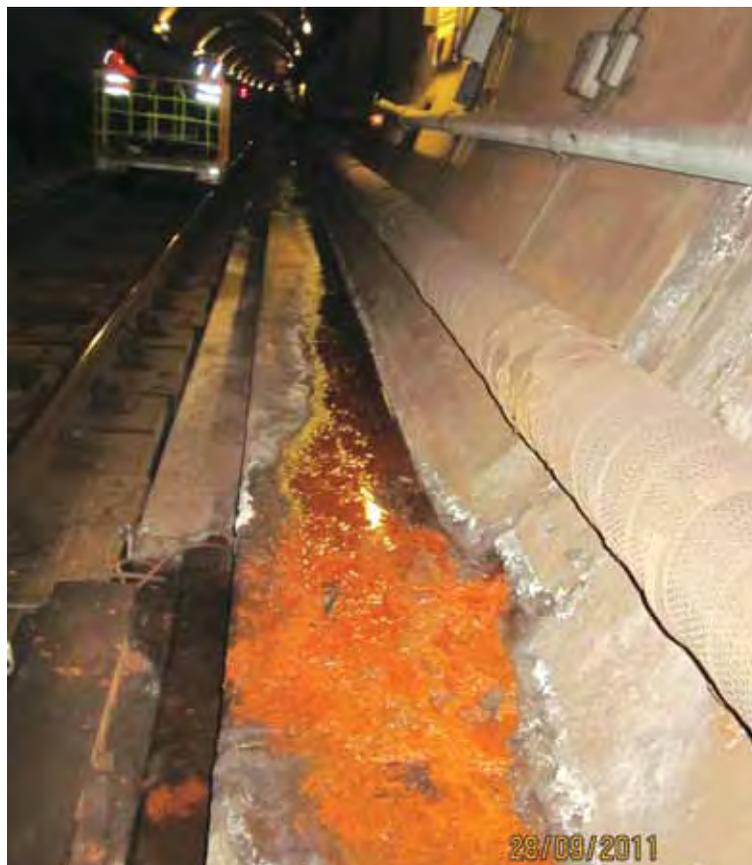
Figure 1: Burnley Loop – severe leached rust water on walkway

During an inspection of the MURL, my investigators observed that parts of the walkways had deteriorated to the extent that walking on them was hazardous (see figure 1).

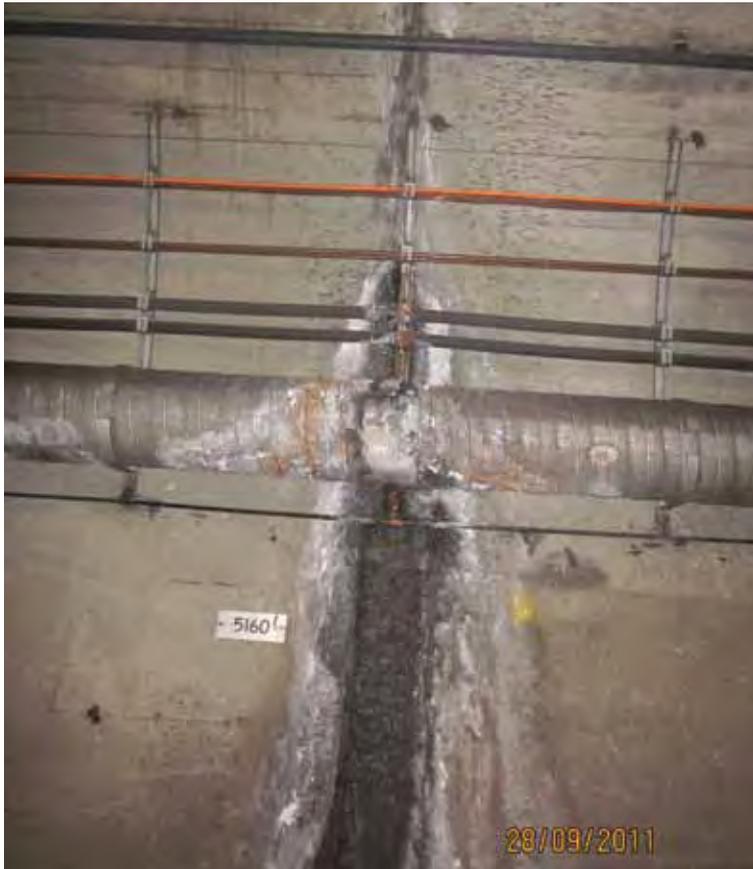
Figure 2: Burnley Loop - high wall cracking and leaching of concrete

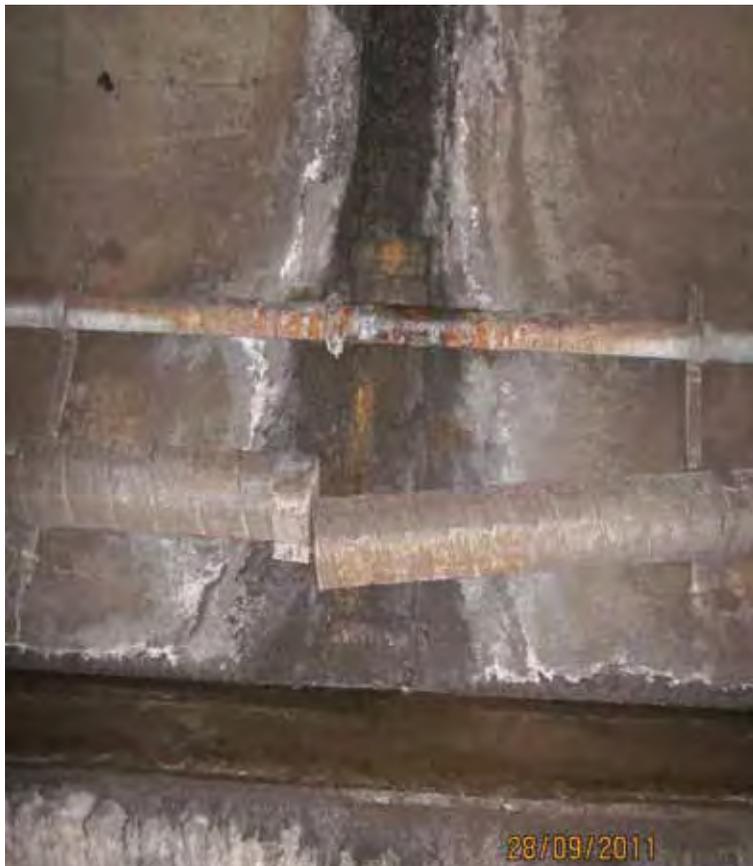
Figure 3: Burnley Loop - corrosion

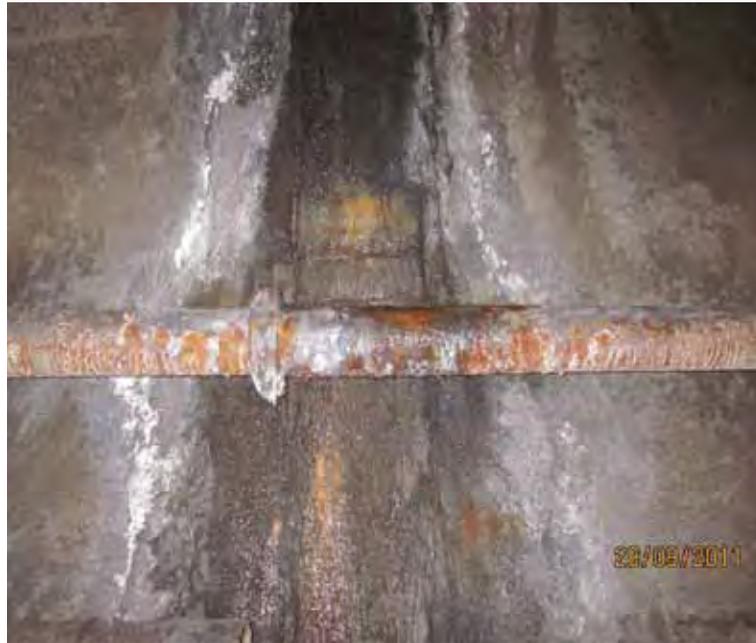
Figure 4: Burnley Loop - severe corrosion on fire line

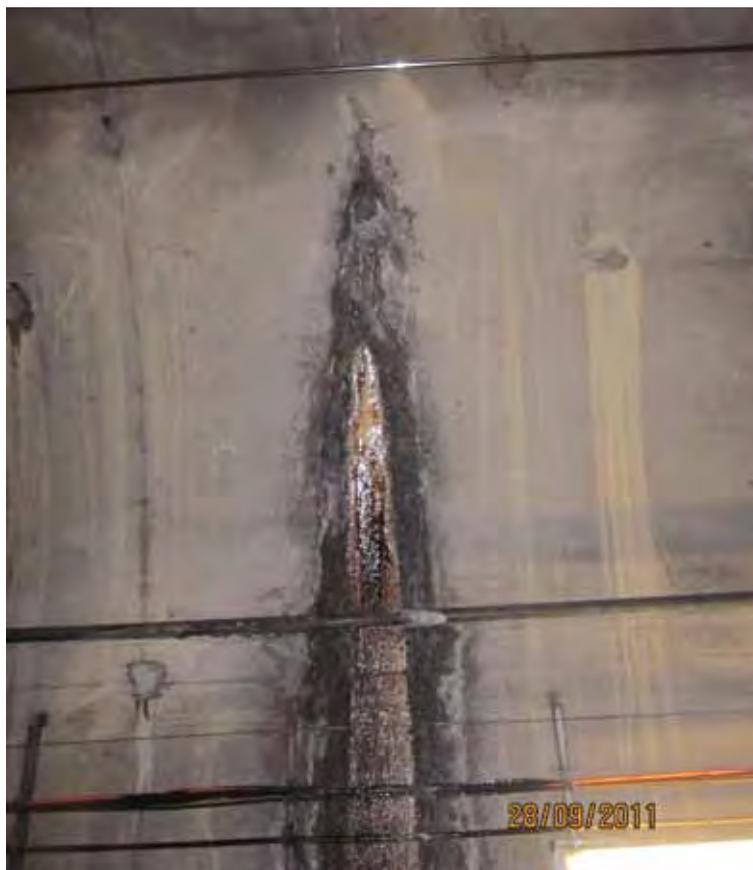
Figure 5: Northern Loop - high wall corrosion and cracking

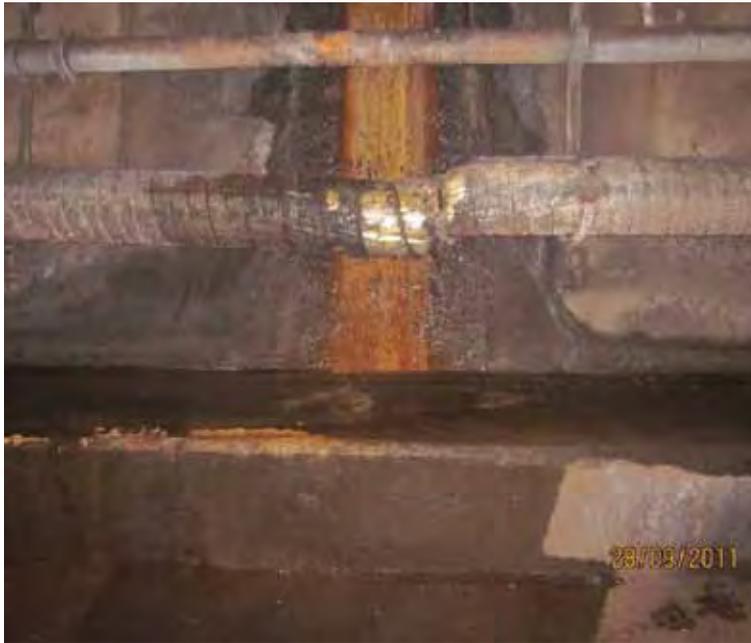
Figure 6: Northern Loop - severe corrosion and leaching
